Impact of Abrasion on Coastal Ecotourism Area in Medang Kampai District, Dumai City, Riau Province

Anugrah Ramadhan Harahap^{1*}, Aras Mulyadi¹, Rifardi¹

¹*Department of Marine Science, Faculty of Fisheries and Marine, Universitas Riau, Pekanbaru 28293 Indonesia*

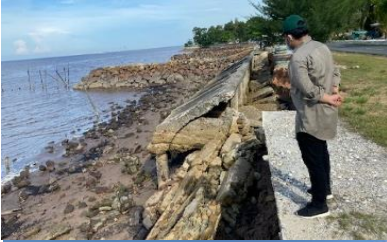
This area is experiencing severe erosion, creating a very steep beach. Coastal vegetation cannot grow again in this area.
3	Koneng Beach

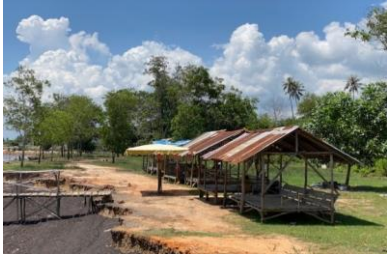
This area experienced relocation of facilities and infrastructure due to abrasion. The abrasion is also due to the change in function of the green belt as a coastal buffer into a residential and tourist area so that nothing is left to stop the abrasion rate.
4	Beautiful Acacia Beach Guntung

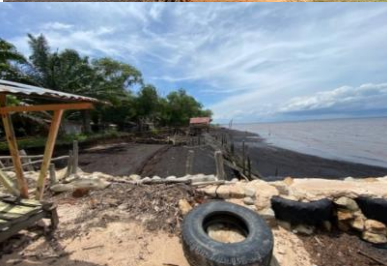
This area has beaches that tend to be flat so that beach erosion occurs more easily. The result of easy erosion is the reduction in beach area, especially the area of tourist attractions, so managers must respond quickly to deal with abrasion.
